KOZANOĞLU
KOZMAKSAN

PTO Troubleshooting

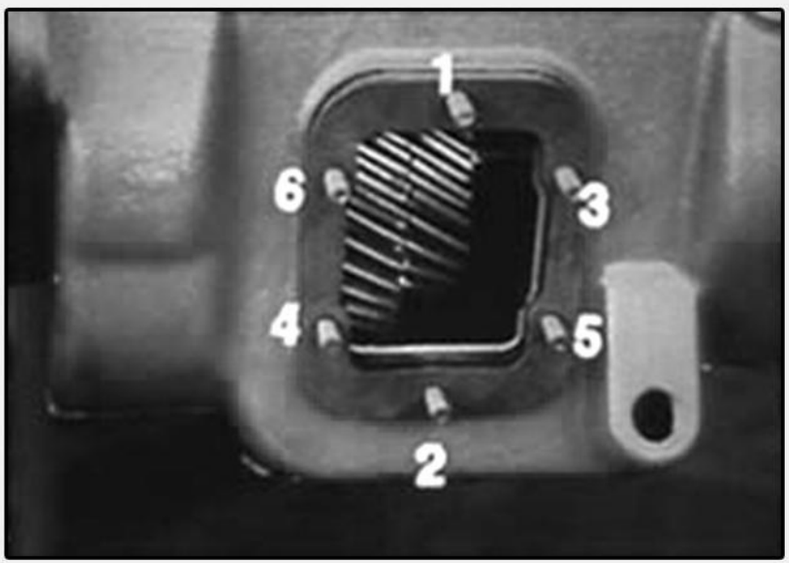
Leaks

Possible Locations

- Stud Threads
- Seals

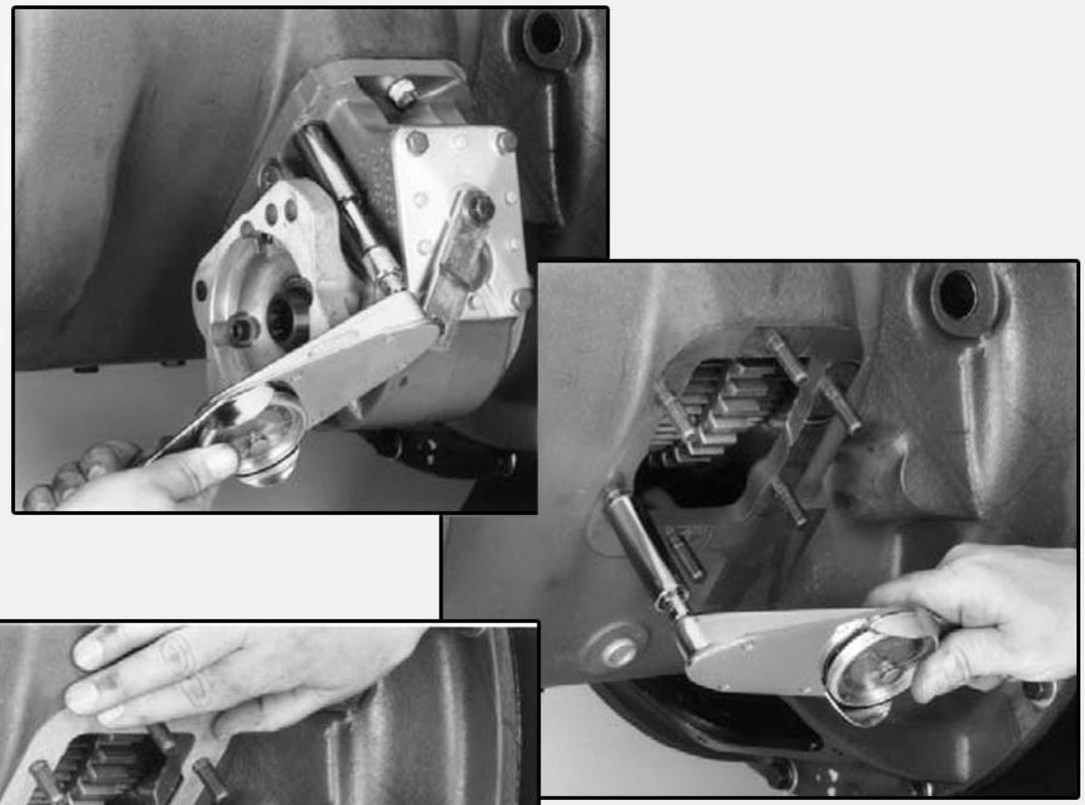
Leaks

Root Cause of the Leakage

- Improper Torque of Fasteners
- Improper Stud Installation
- Gasket Installation

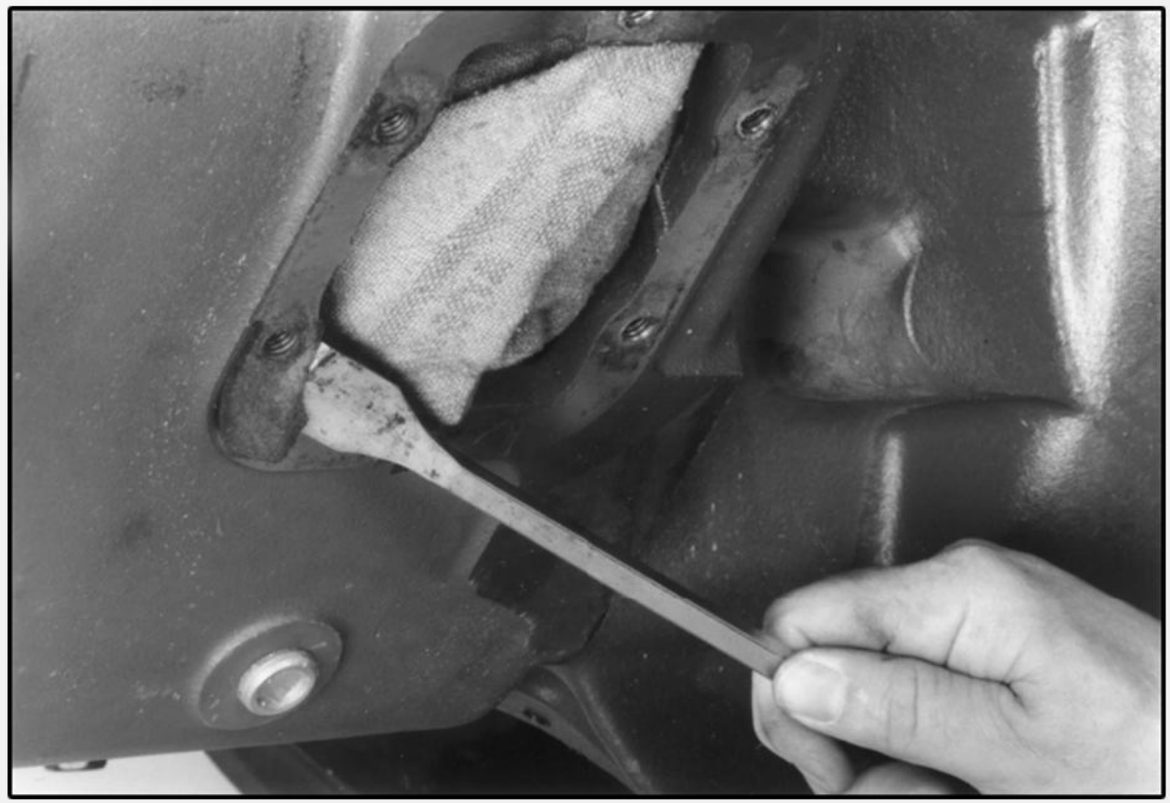
Leaks

Root Cause of the Leakage

- Transmission Preparation
- Worn Seals

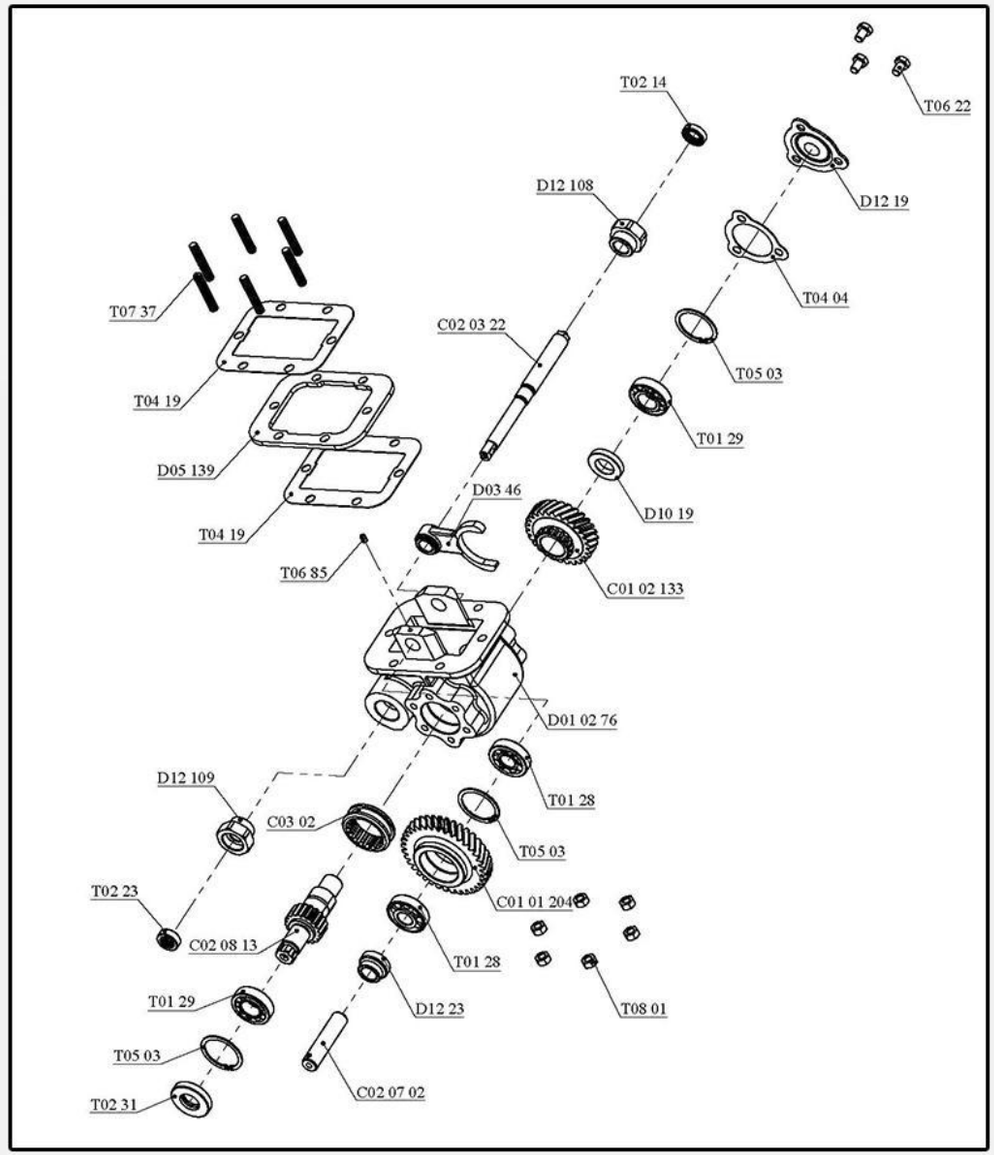
Performance

Symptoms & Causes

- Hydraulic System
- PTO Operation
  - Erratic Operation
  - Hard Shifting
  - Jumping out of Gear

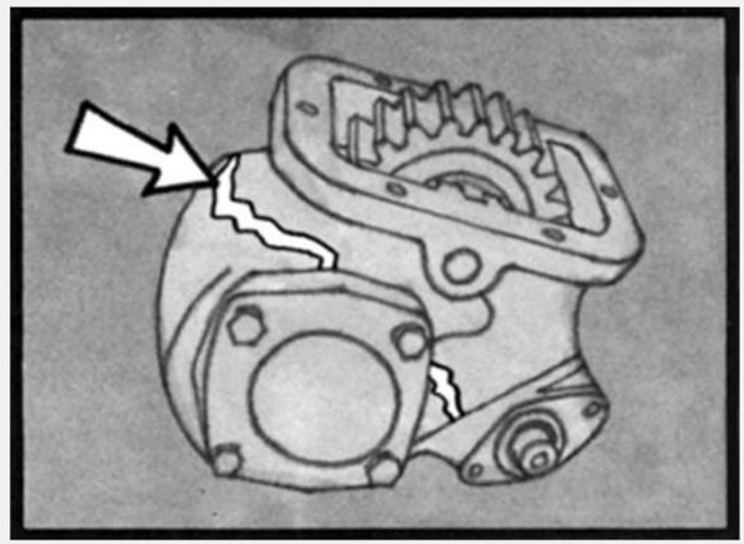
Housing Damage

One of the most serious problems a PTO can suffer is a cracked case. This condition can lead to oil loss and eventual transmission failure.

Some causes are:

- Improper installation
- Poorly torqued bolts
- Unsupported direct mount pump
- Foreign objects meshing between the gear teeth
- Severe shock load
- Hitting an obstacle in the road.

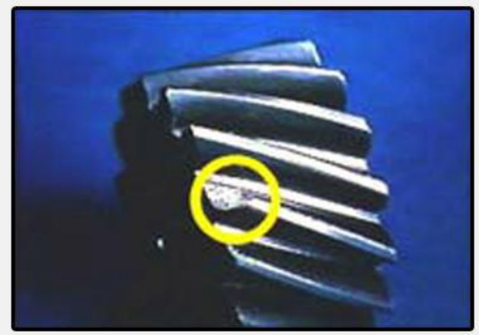
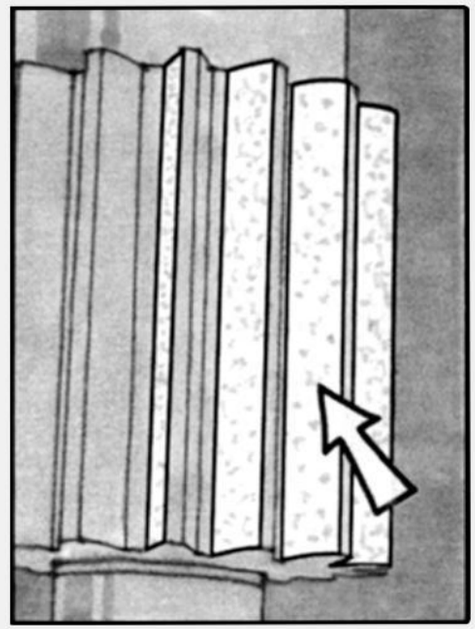
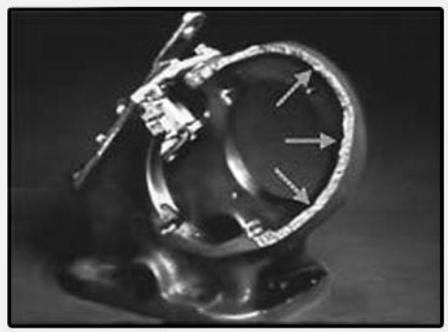
Gear Damage

- Tooth
- Spline
- The first parts to inspect should be the gears.

Check the surface of the gear teeth for signs of pitting.
- Once pitting of the gear surfaces has begun,

there is nothing that can stop it.

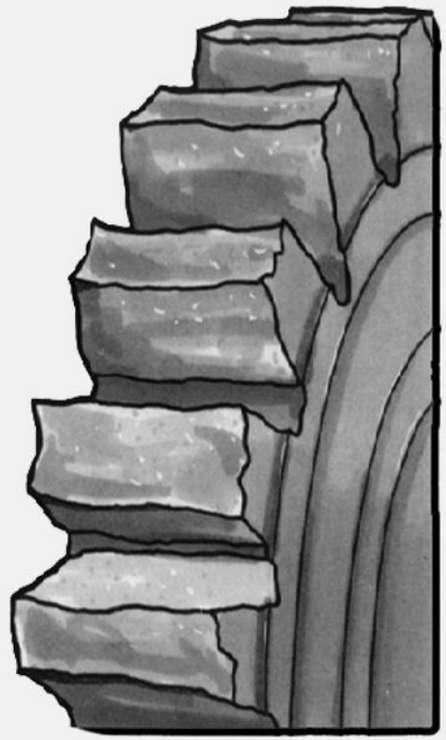
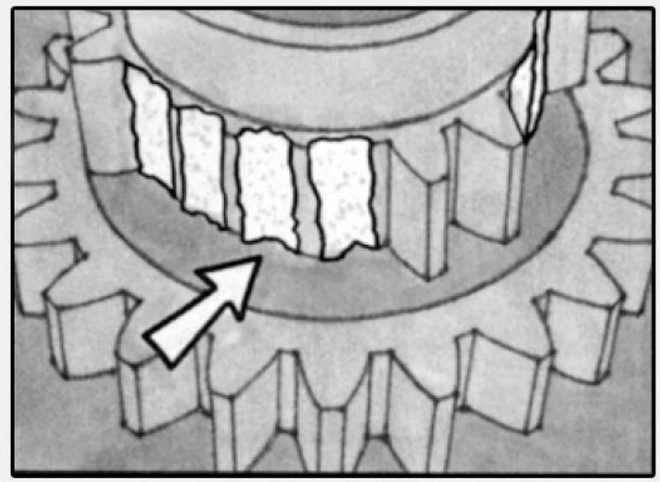
Gear Damage

Another possible problem during vehicle operation is “shock load”.

- Deep Mesh Pattern Caused by Improper Backlash Adjustment.

Worn gears can easily be affected by “shock load”.

If the worn gears are not replaced, they can eventually lead to broken gear teeth.

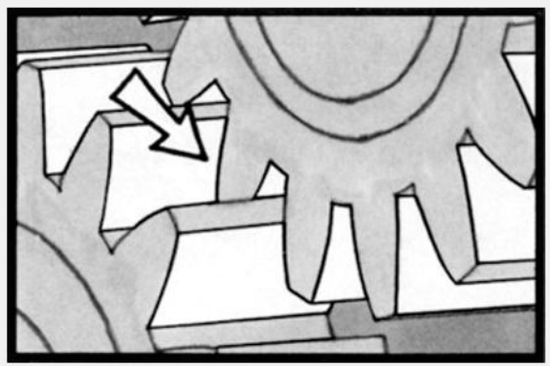
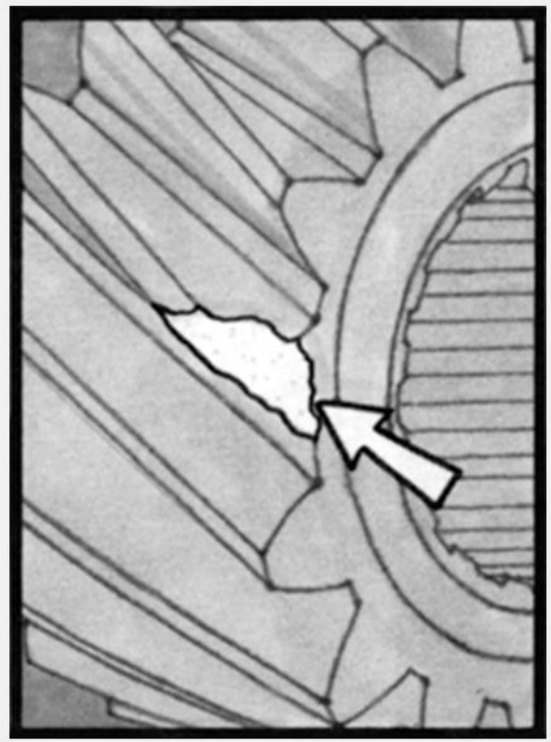
Gear Damage

Sometimes a gear will chip a tooth because of mishandling or improper shifting.

Undershifting allows incomplete gear tooth contact with the driver gear. This means only part of the tooth width is transmitting the torque and RPM during PTO operation.

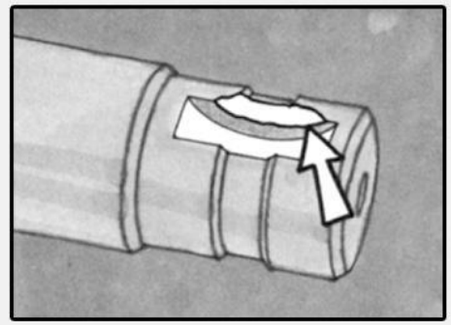
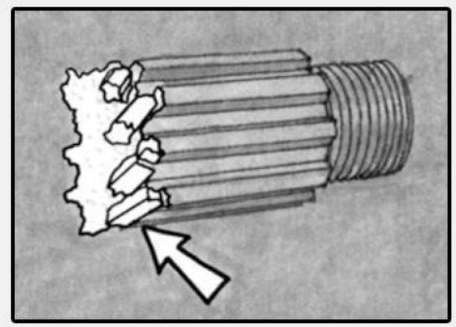
Shafts

Damage

- Misapplication
  - Overloads
- Shock Loads
- Seals
- Bearing

PTO shafts are also vulnerable to operating abuse.

- Torsional overload
- Bending fatigue failure

When inspecting a PTO output shaft, always inspect the keyway.

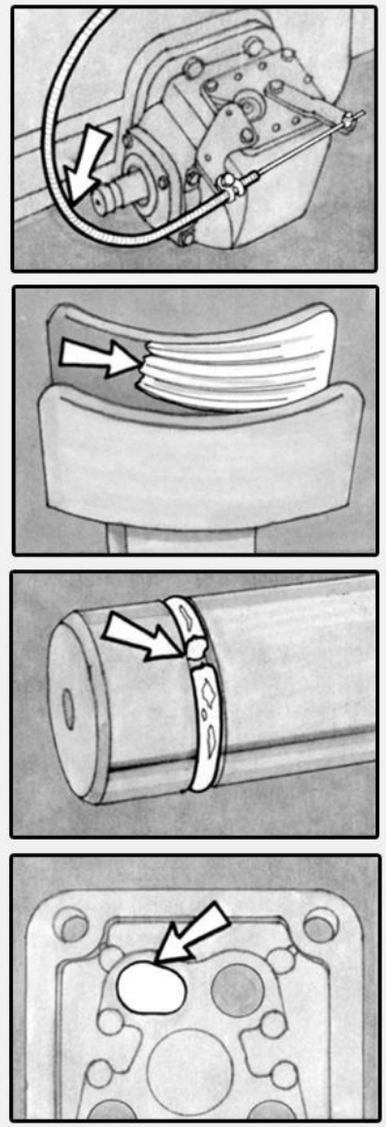
Shifting Problems

- PTO is hard to shift.
- Most shifting complaints are caused by improper shifting procedure or incorrect linkage installation.
- Shifting problems can also be caused by a worn or elongated shifter poppet hole.
- Seals and O-Rings may cause special problems in PTO operations.

Remember, a lever-operated shift linkage should not be connected to a wire shift cover. The mechanical advantage of the lever is often too great for the wire shift cover and could severely damage it. Also inversely, don't use a cable with a lever shift cover. The cable isn't capable of transmitting the force necessary to shift a lever mechanism.

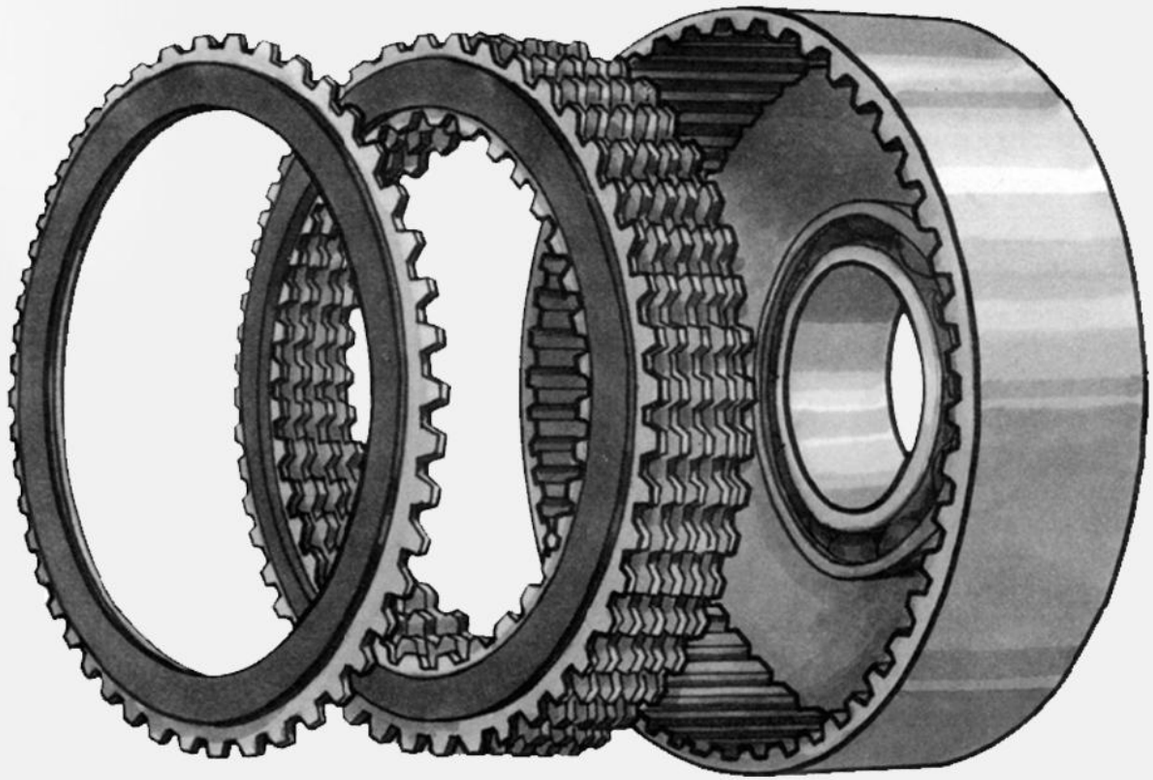
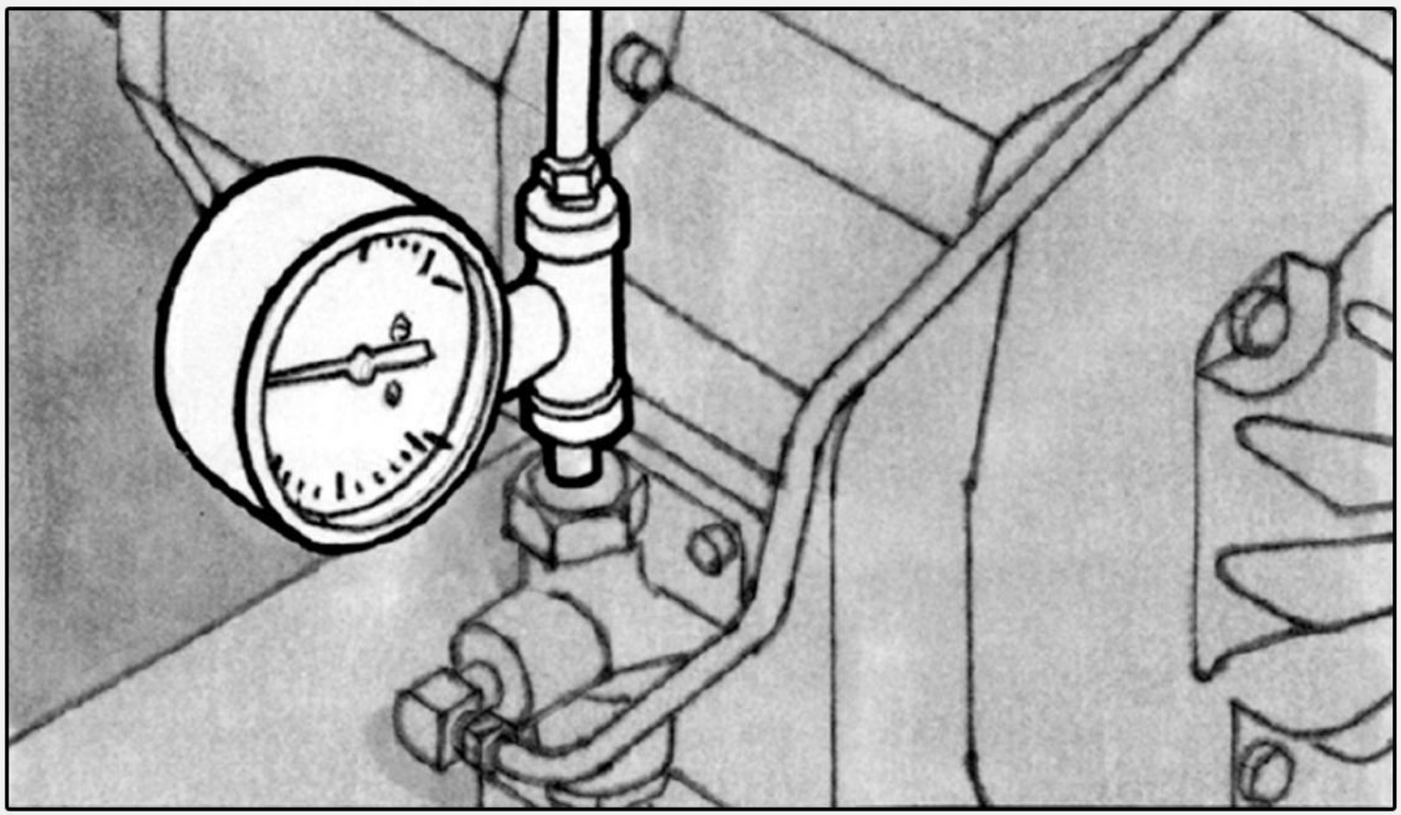
Remember, when troubleshooting any clutch-operated PTO carefully inspect all components for wear or damage. Burnt clutch plates, welded clutch pack, or a burnt driving hub are three easily identifiable conditions that lend themselves to failure analysis.

Burnt Clutch Plates?

Welded Clutch Pack?

Burnt Driving Hub?
